**SAFETY COMPLIANCE TESTING FOR FMVSS 201  
Occupant Protection In Interior Impact  
Upper Interior Head Impact Protection**

**HYUNDAI MOTOR COMPANY  
2006 Hyundai Accent 4-Door Sedan  
NHTSA No. C60508**

**FINAL REPORT**

| 1. Report No.<br>201UI-MGA-06-02 | 2. Government Accession No. | 3. Recipient's Catalog No. | |

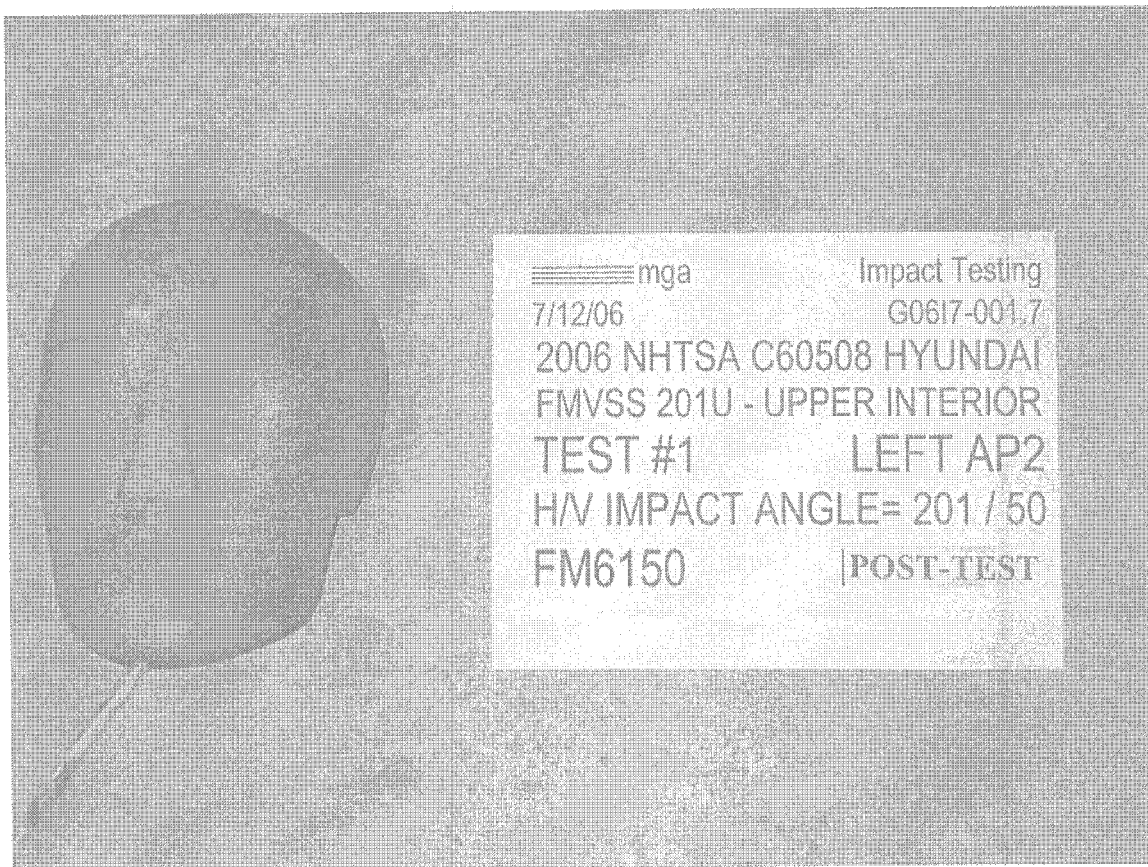
A-pillar cracked and dislodged.
